Manhole Inspection Summary

Manhole # S15U__013MH

Insp Date: **6/25/08 2:25 PM**

Location Address: **2717 wilmarco av**

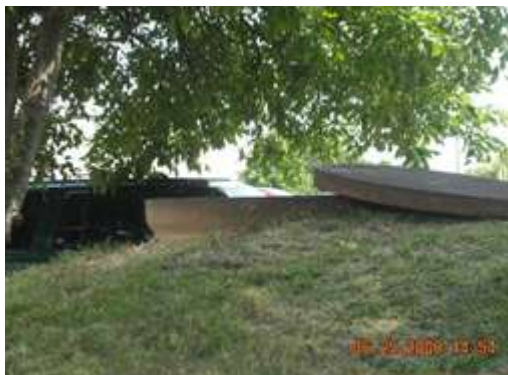
Misc

frame above grade

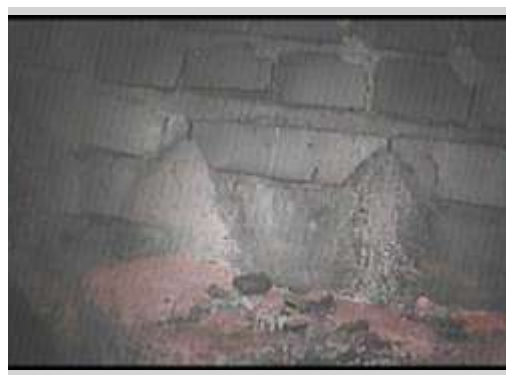
Defect 4

Infiltration: ☐ None ☐ Joint ☐ Cracks ☐ Mortar ☐ Roots ☒ **Wall**

infiltration @ barrel wall

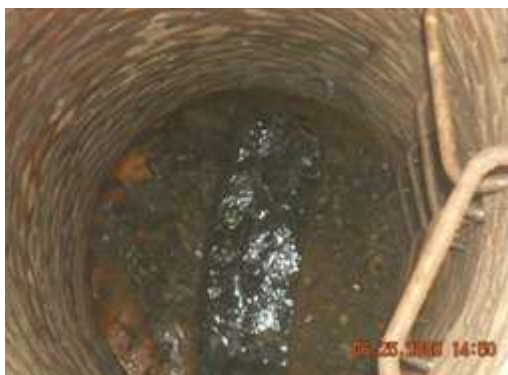
Defect 2

Condition: ☐ Sound ☐ Cracked ☐ Root Intrusion ☐ Deteriorated ☐ Leaks ☒ **Debris**

debris in channel

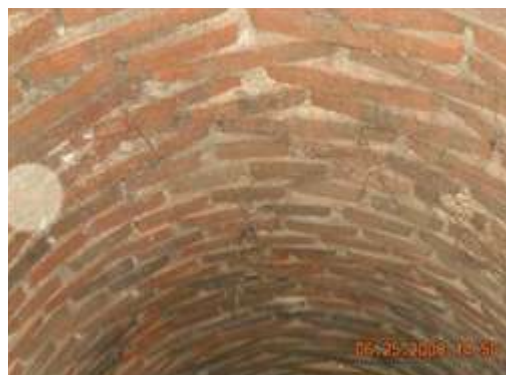
Defect 1

Condition: ☐ Sound ☐ Cracked ☒ **Root Intrusion** ☐ Loose Brick ☐ Deteriorated

root intrusion @ corbel wall

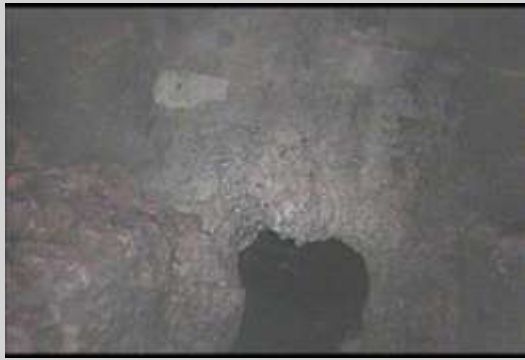
12 O'Clock Outflow

Pipe Height: **12** (in.) Rod and Bar (Angled)
Pipe Material: **Clay** ☐ Pipe Lined
Invert Depth: **19.50** (ft.) Flow Characteristics: **Slow**
Deposits: ☐ None ☒ Mud ☒ Sludge ☐ Debris ☒ Grease
Silt Depth: **8** (in.) Deposits Extent: **Heavy**
Infiltration: **None** Pipe Seal Cond: **Unknown**
